**Dominion**

# **DAM INSPECTION CHECKLIST POSSUM POINT POWER STATION POND ABC**

INSPECTION DATE: 5/18/15

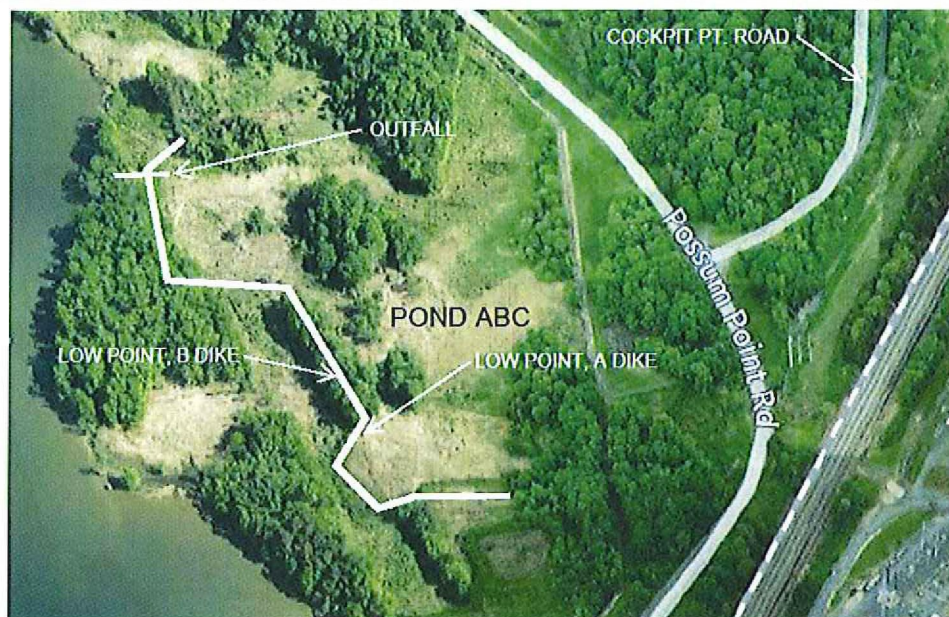
\* See figure below.

Location/ Condition	(y/n)	Change (y/n)	Comments
Low Point, A dike*			
Flow	N	N	1335 hrs. Standing water along perimeter of pond
Erosion	N	N	near road. Small amount of stagnant standing water
Low Point, B dike*			
Flow	N	N	1337 hrs. Sandbags and rip rap in place. No
Erosion	N	N	standing water.
Outfall water surface El. (top of stoplogs to water)			1343 hrs. Standing water behind concrete weir structure. 43". Standing water behind sandbags. No seep or flow into discharge pipe.

Additional Comments (Note any changes observed along the embankment crest or downstream slope observed from the crest.): Rainfall event of 1.14" ending ~ 1400 on 5/17/15. Standing water at the base of the slope between A and B pond.
